# Power saver

## *Leakage current properties of modern electrolytic capacitors*

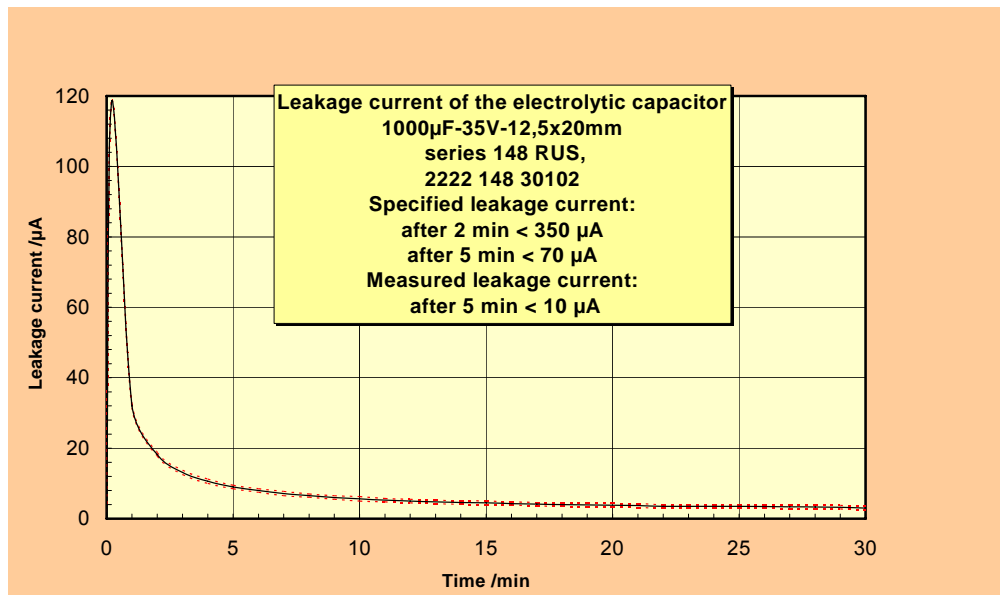
Figure 3  
Typical time behavior of the leakage current of an aluminium electrolytic capacitor after switching on

As the curve in Figure 3 shows, the leakage current after 5 minutes in this example is by far lower than the 5-minute acceptance limit value of 70  $\mu\text{A}$ . And in this example the measured leakage current value approaches a constant, small value of around 5 to 10  $\mu\text{A}$  on an asymptotic basis. This final value is known as the **operating leakage current** and has usually established itself after around one hour. After this time all the weaknesses in the dielectric of the electrolytic capacitor of the modern professional electrolytic capacitor supplied today have been healed and the leakage current has declined to a

The leakage current value after 2 or 5 minutes, the so-called acceptance value, is relatively high compared to the curve shown in figure 3. It is specified at such a high level because normally various influences of the “previous history”, such as lengthy storage with no voltage, have a major effect on the measurement when the capacitor is switched on for the first time.

The time dependence of the leakage current is shown very clearly in the curve in Figure 3. This behaviour results from the self-healing effect of the electrolytic capacitor and the anodic oxidation or forming of the dielectric. After all, weaknesses in the dielectric, which can be created by chemical processes on the oxide layer during storage or as a result of mechanical damage during the production of the device, are healed when a voltage is applied to it. However, time is required for this healing process, also known as the forming process. The weakening of the dielectric, however, is also a question of the previous history of the capacitor. The following example is suitable to explain the term “previous history” in some more detail.

A leakage current value of around 10  $\mu\text{A}$  for a 1000  $\mu\text{F}$  electrolytic capacitor at 35 V (see Figure 3) is therefore by no means uncommon. However, this

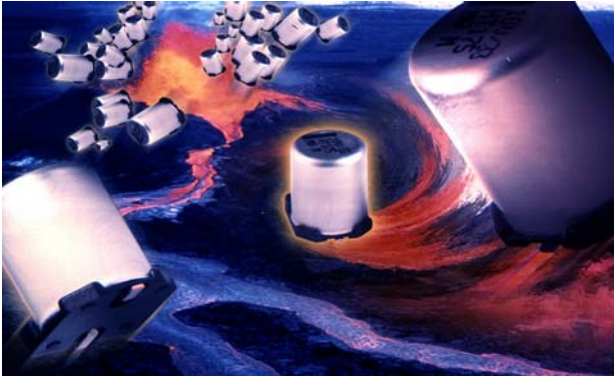
Figure 5  
Series 140 CLZ SMD electrolytic capacitors from BCcomponents are designed for applications with temperatures up to 125 °C

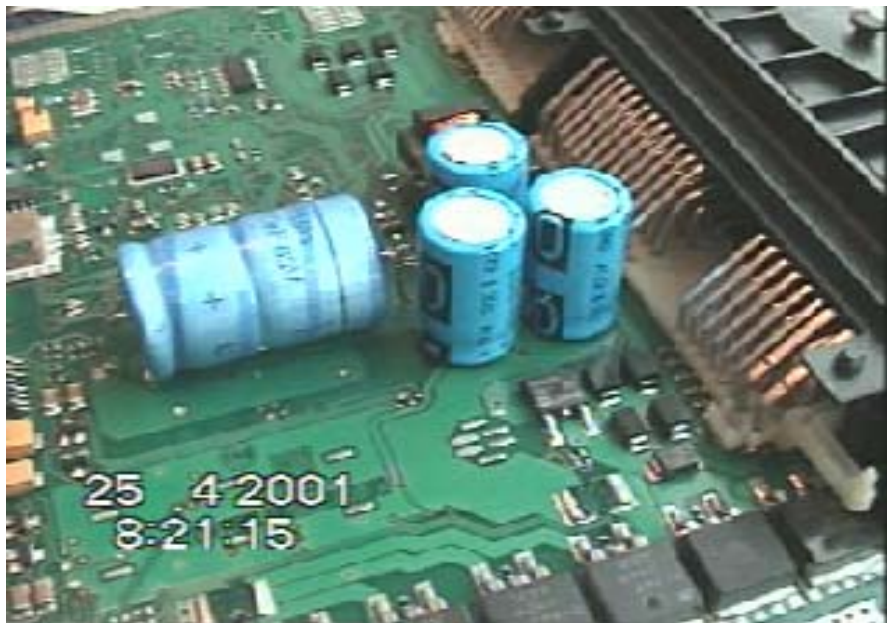
Figure 10  
Electrolytic capacitors in a motor vehicle injection circuit from Bosch

In another former motor vehicle application, however, high efforts have been made to achieve very good leakage current properties from the very beginning. The former flashers in a car were activated using timing elements (RC elements). If the leakage current increases too much, the flasher frequency changes. The motor vehicle approval authorities were very strict in this respect. The flashing frequencies had to be within precisely defined limits. The discussion about timing elements using a resistor and an electrolytic capacitor also resulted in the rule of thumb for the function of a circuit of this type – the current defined by the series resistor should be 10 times as high as the 5 minute value for the leakage current of the electrolytic capacitor.

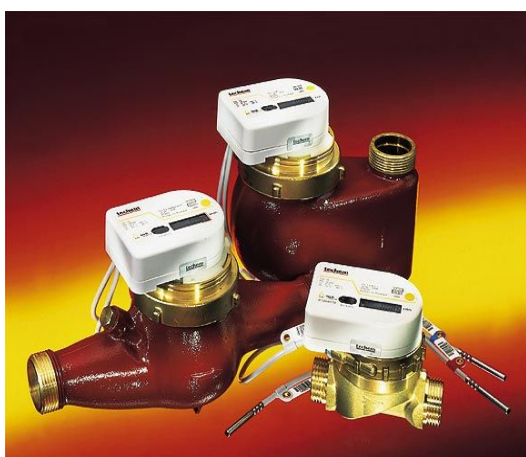
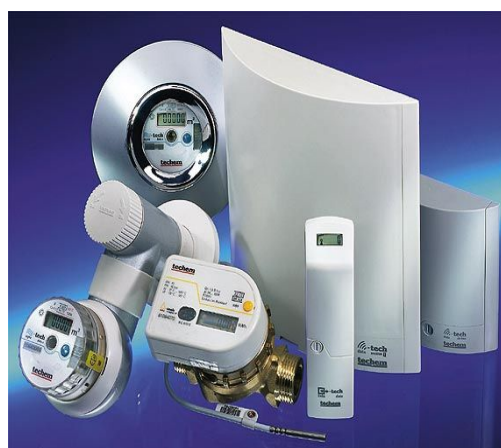
Figures 11 and 12  
Heat metering devices, Techem

The heat meter circuit is powered by a lithium battery which supplies the circuit with energy for a period of 10 years without requiring any maintenance.

Extremely high demands on very low leakage current values are very common in an application that affects many households. This application is heating cost readers installed on heating equipment to transmit the temperatures of the radiators to a central computer by means of pulse coding. The reading circuit has no mains connection. The energy for the transmitted pulses for a useful or service life of 10 years is stored in a battery. A buffer electrolytic capacitor provides the low resistivity supply of the transmission energy for the radio signals required in this circuit. This means that the electrolytic capacitor leakage current influences the overall useful life of the reading circuit. It is noticeable that the manufacturers strive hard to reduce the leakage current of the electrolytic capacitor by every possible  $\mu\text{A}$ . The factor that makes this even more difficult is that the circuit on the radiator becomes hot and the leakage current increases with the temperature.

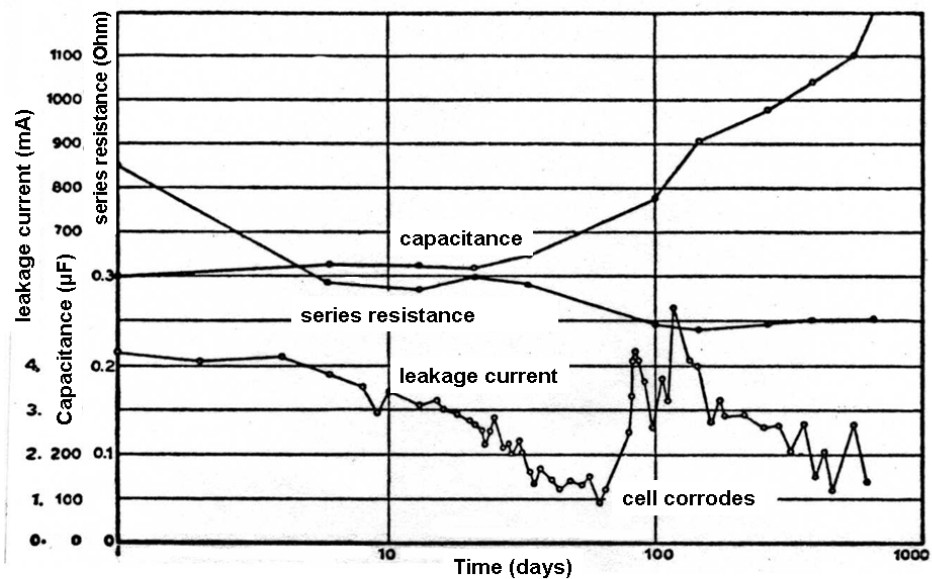
Figure 14  
Curves showing the capacitance, the series resistance and the leakage current in an 1000 hours endurance test on a 700 µF/65 V electrolytic capacitor dating from 1929  
Peculiarity: Corrosion and its influence on the leakage current

experienced in the sixties. High leakage current and even short circuits were often found in electrolytic capacitors at that time. The reason for the corrosion problems in electrolytic capacitors included impurities, particularly with halogens such as chloride. Chloride acts as a catalyst for aluminium corrosion in the electrolytic capacitor. This process goes hand in hand with increased forming work, in other words with increased leakage current.
